**Enbridge Line 6B MP 608 Pipeline Release
Marshall, Michigan**

**Permanent Recovery of Submerged Oil and Oil-Contaminated
Sediments at Priority Locations**

Submerged Oil Recovery Summary Report

**Enbridge Energy
October 29, 2010**

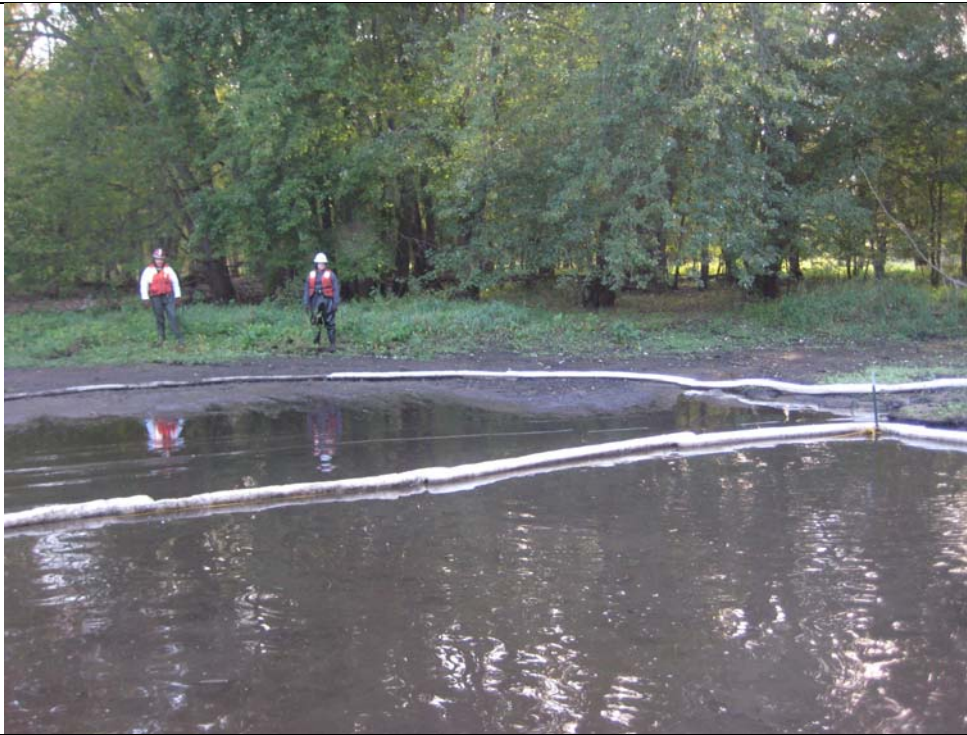
Photograph 4

Description:
Recovery activities in
progress – cells prepared

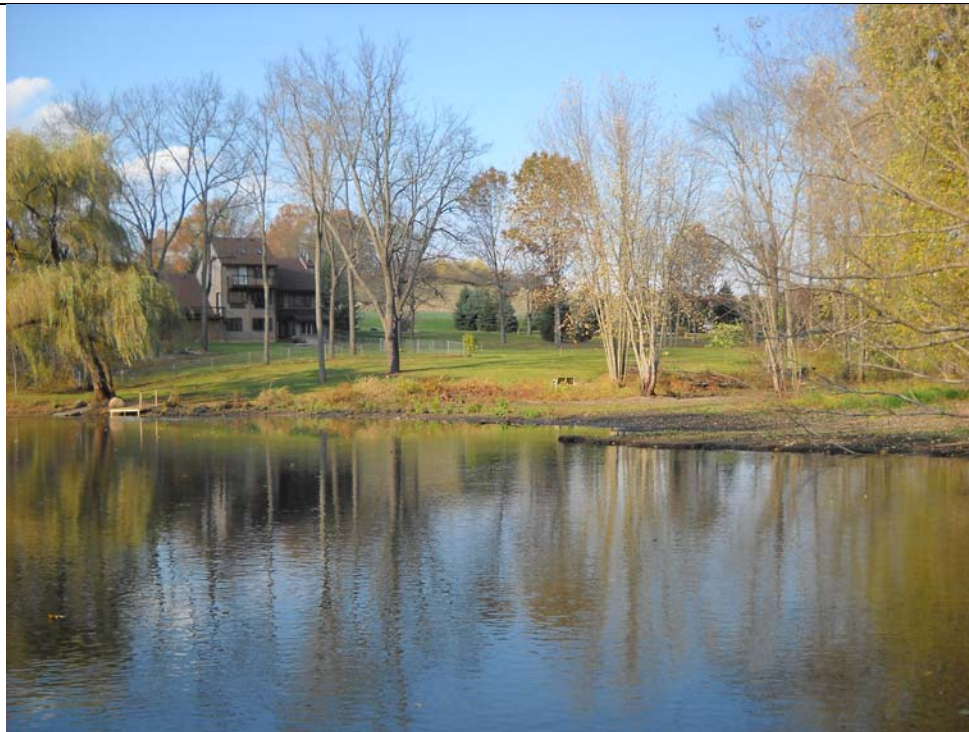
PHOTOGRAPH LOG
Photograph 5

Description:
Post Recovery – Recovery
activities complete and
containment removed

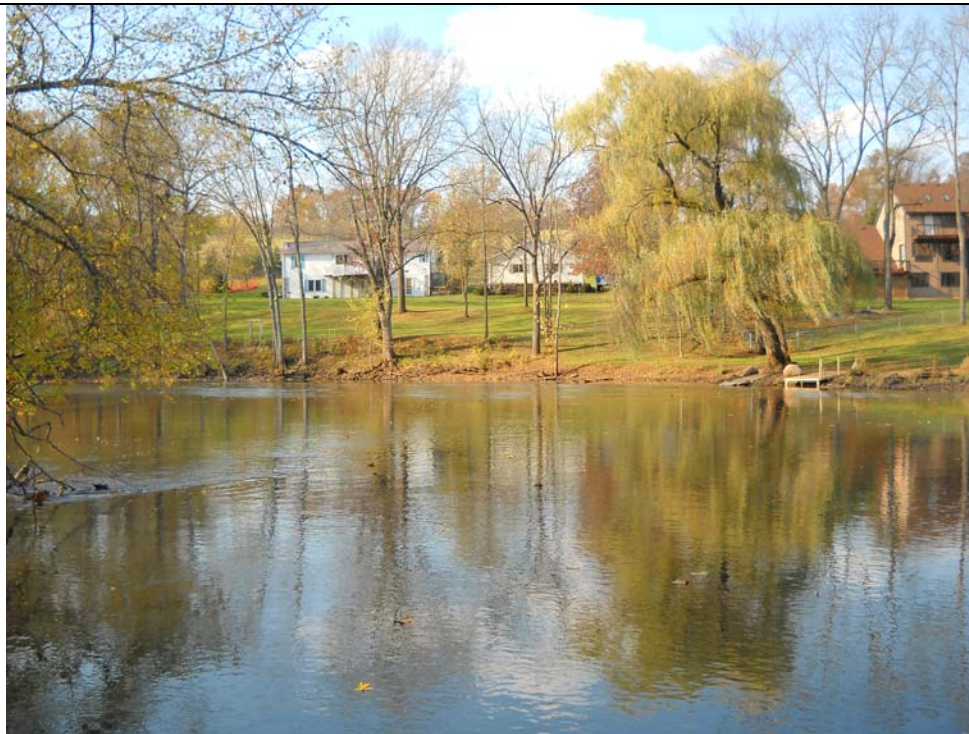
**PHOTOGRAPH LOG**
Photograph 6

Description:
Post Recovery – Recovery
activities complete and
containment removed

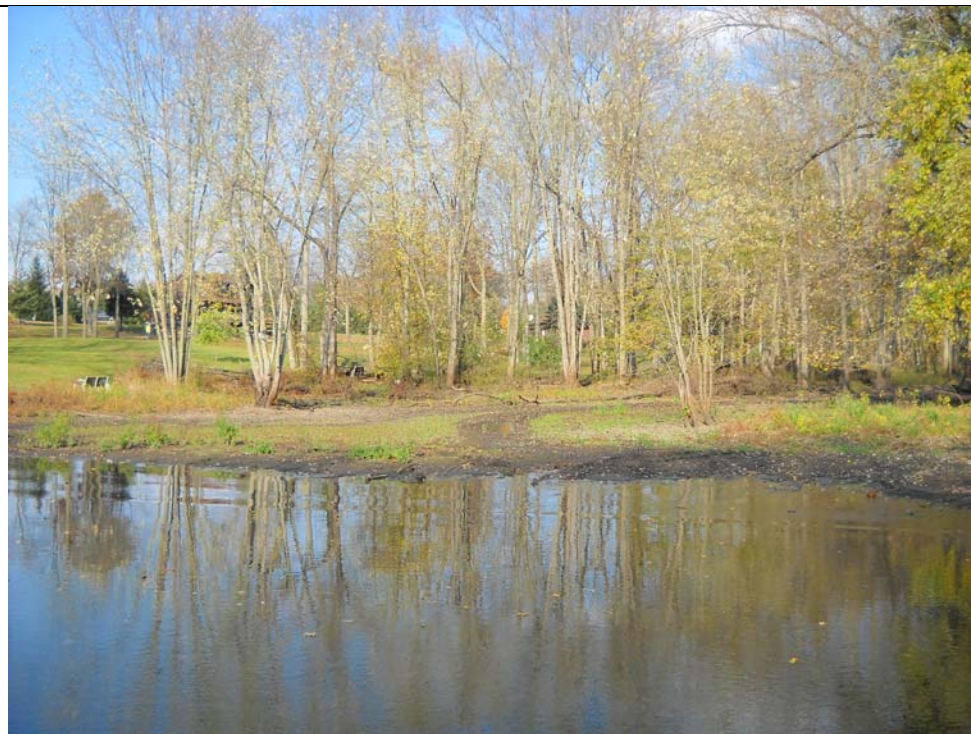
Photograph 7

Description:
Post Recovery – Recovery
activities complete and
containment removed

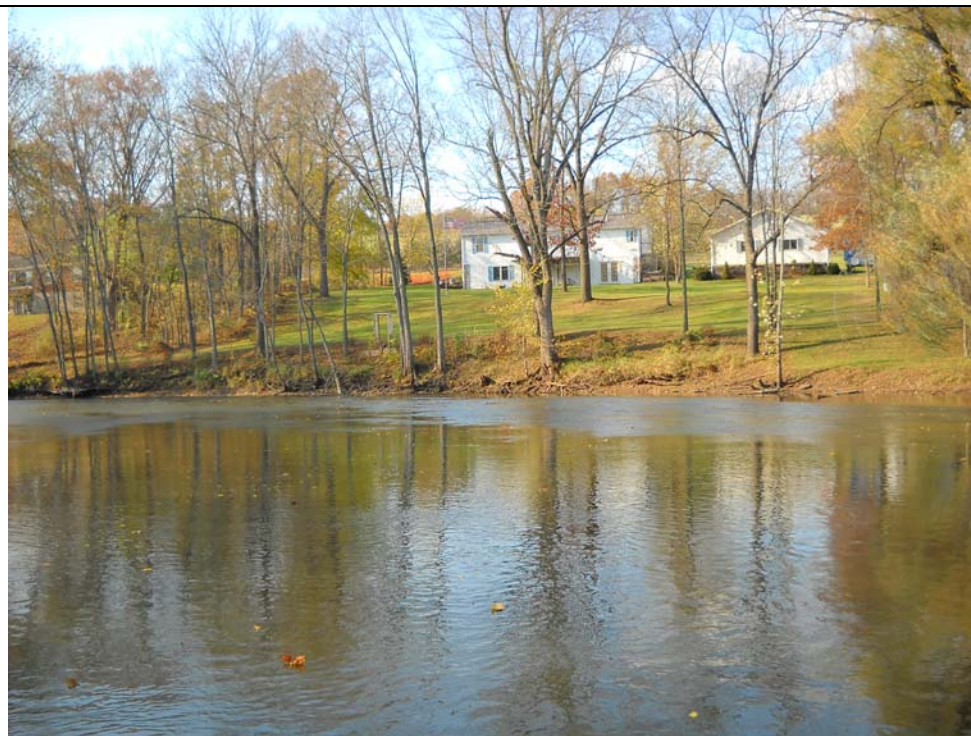
Photograph 8

Description:
Post Recovery – Recovery
activities complete and
containment removed

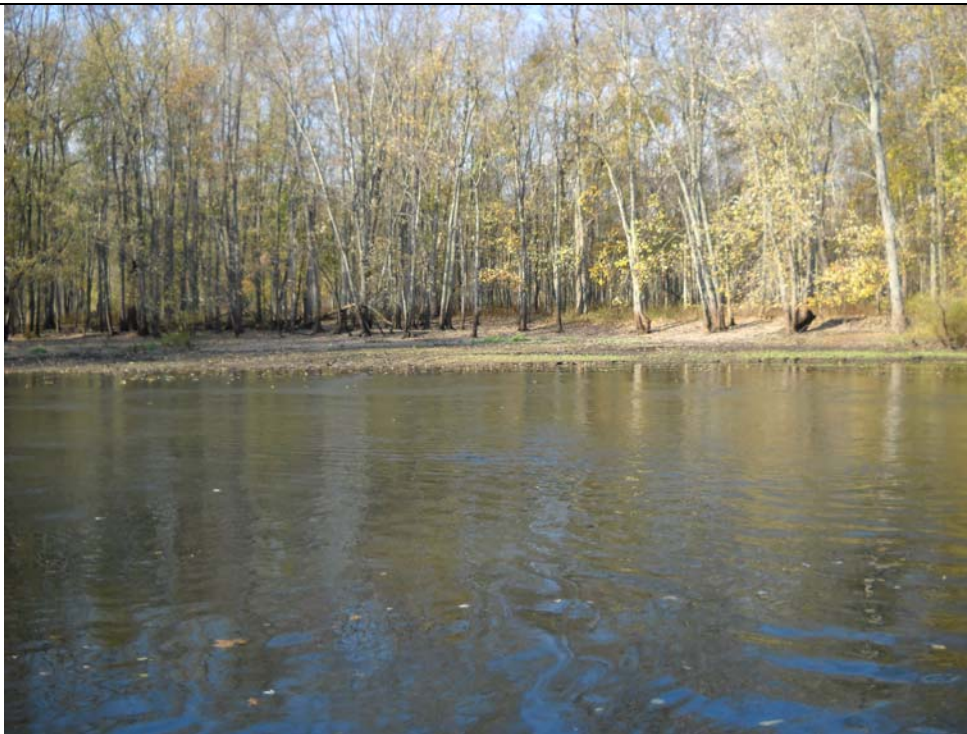
Photograph 2

Description:
Post recovery – recovery
activities complete and
containment removed

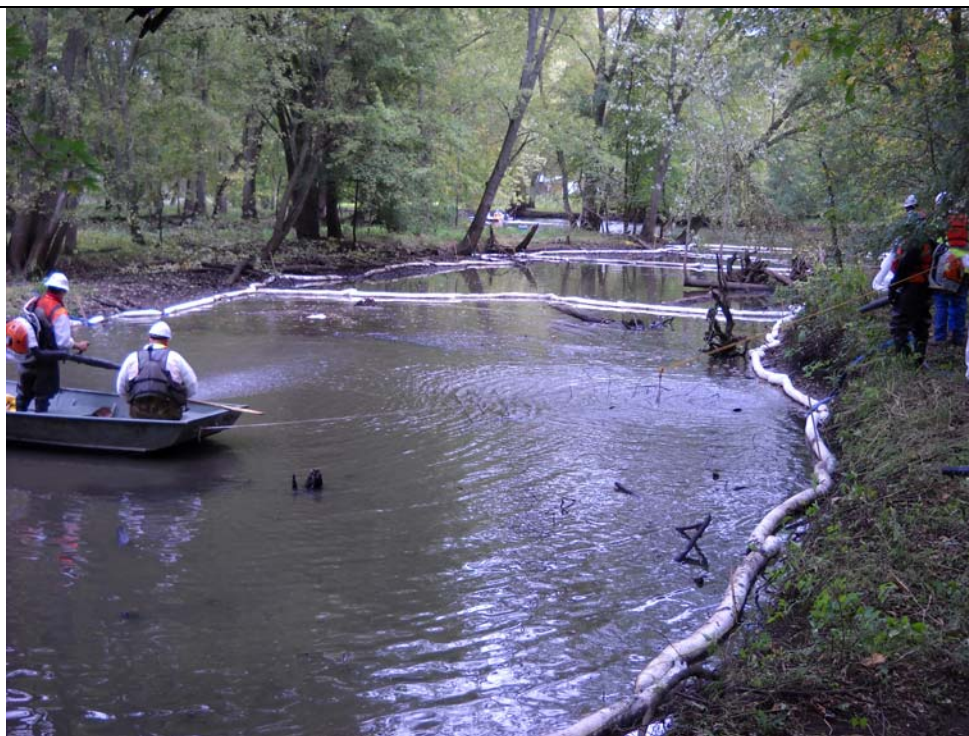
Description:
Recovery activities in progress – using leaf blowers to collect oil

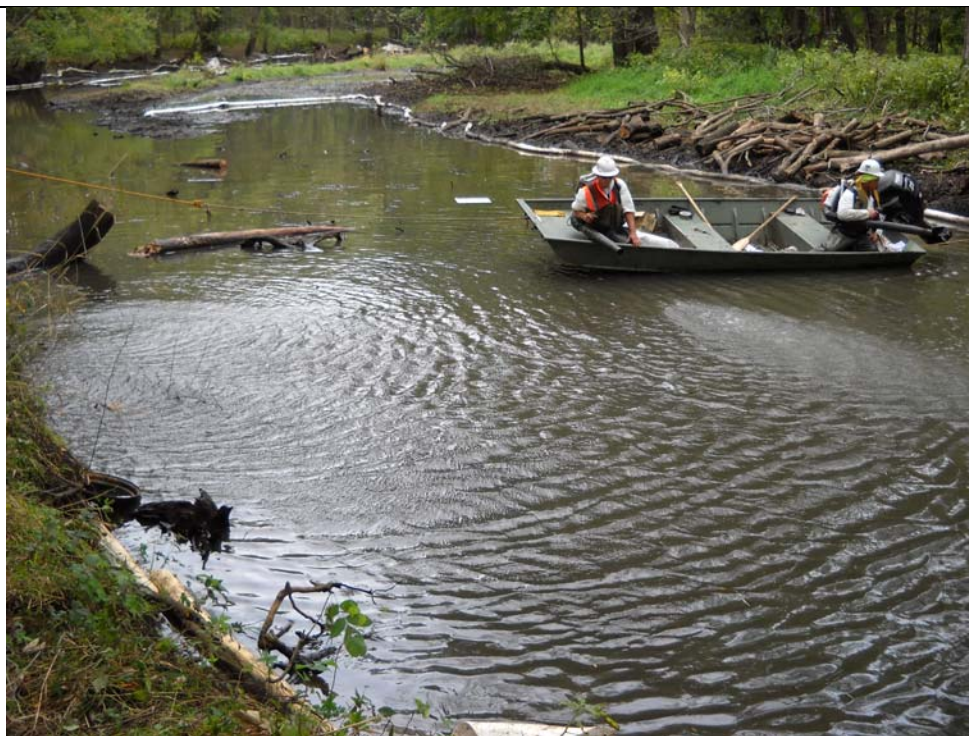
**PHOTOGRAPH LOG**
Photograph 2

Description:
Recovery activities in progress – using leaf blowers to collect oil

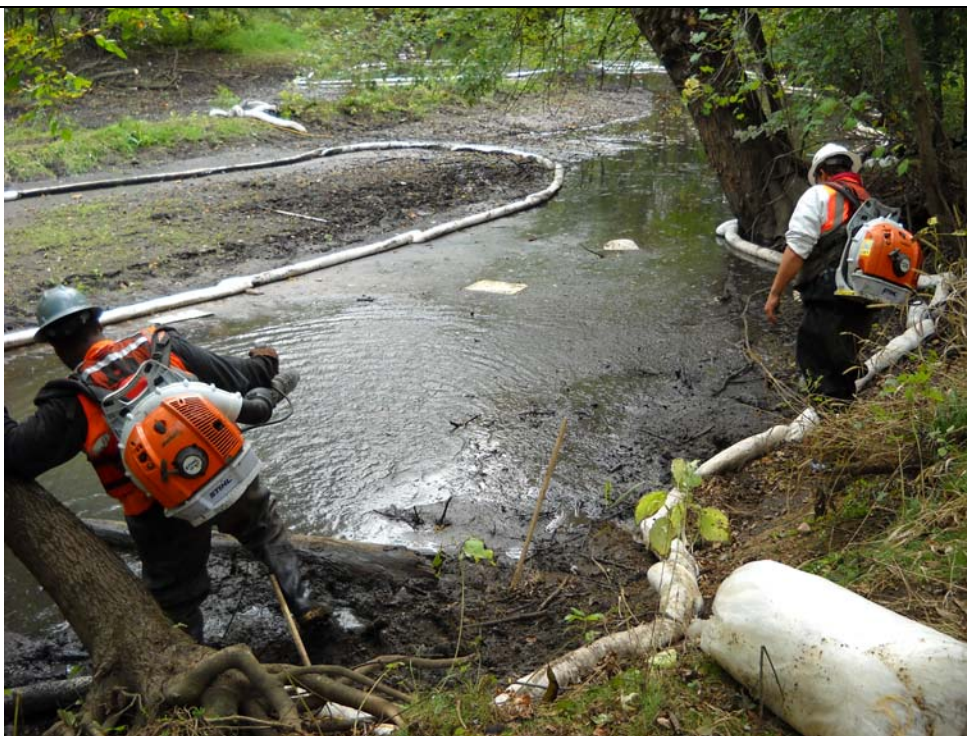
PHOTOGRAPH LOG
Photograph 3

Description:
Recovery activities in progress – using leaf blowers to collect oil

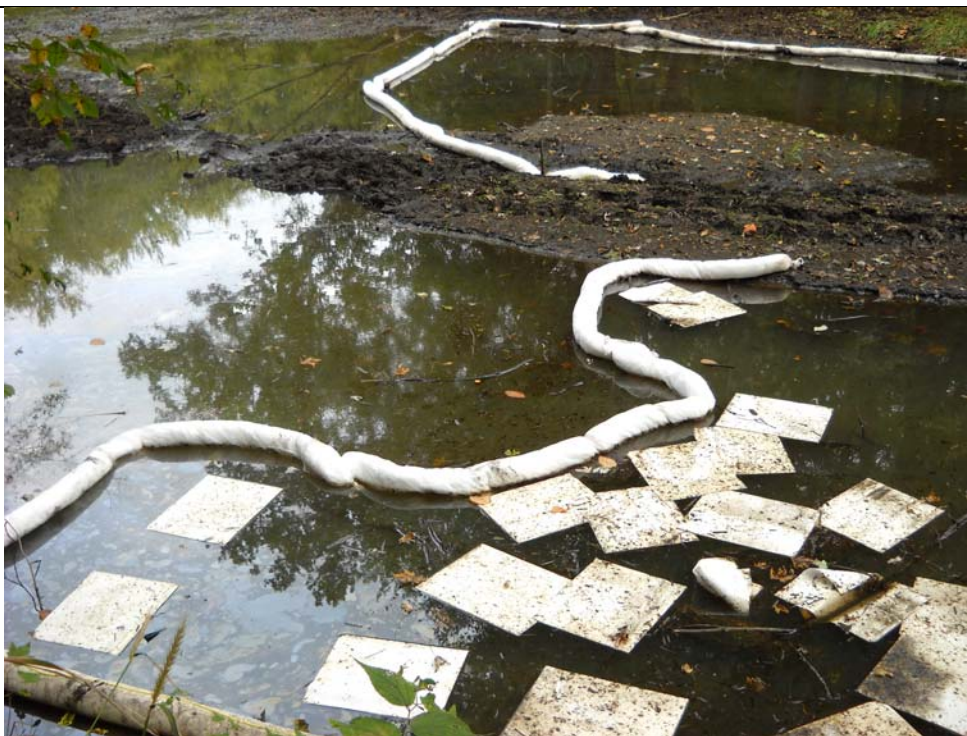
**PHOTOGRAPH LOG**
Photograph 4

Description:
Recovery activities in progress – pads and boom deployed for oil collection

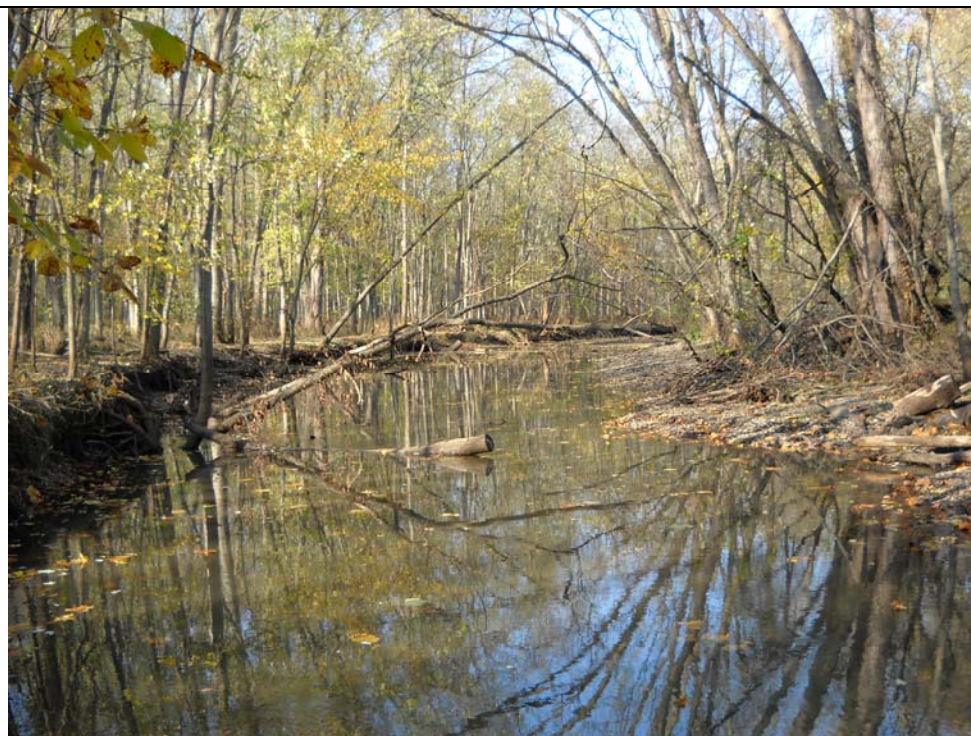
PHOTOGRAPH LOG
Photograph 5

Description:
Post recovery – recovery
activities complete

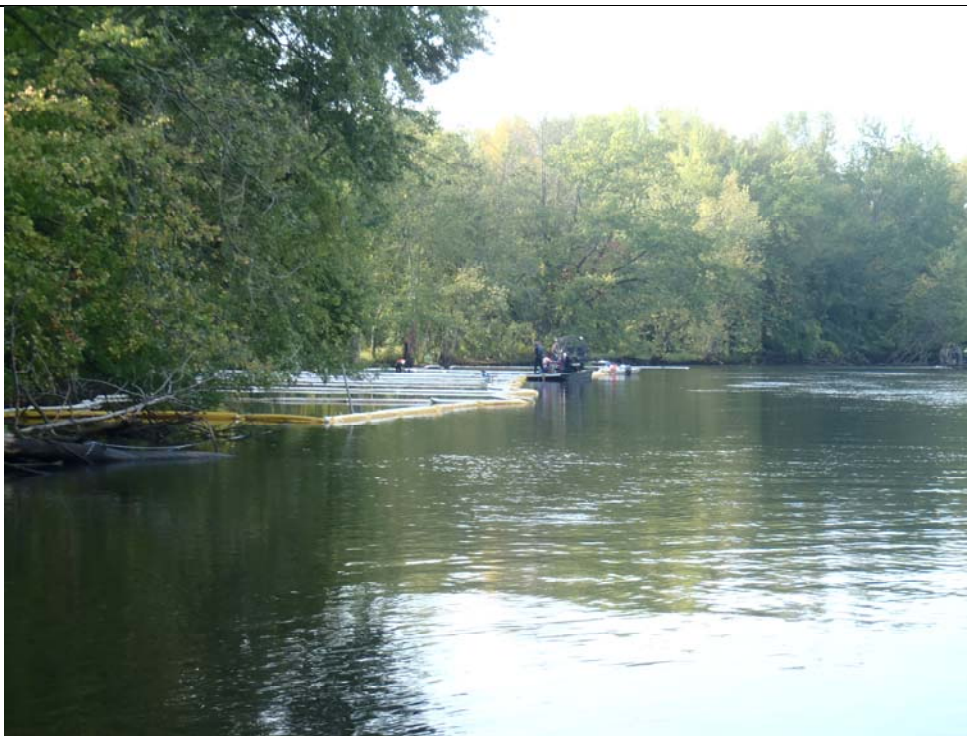
Description:
Recovery activities in
progress – aeration

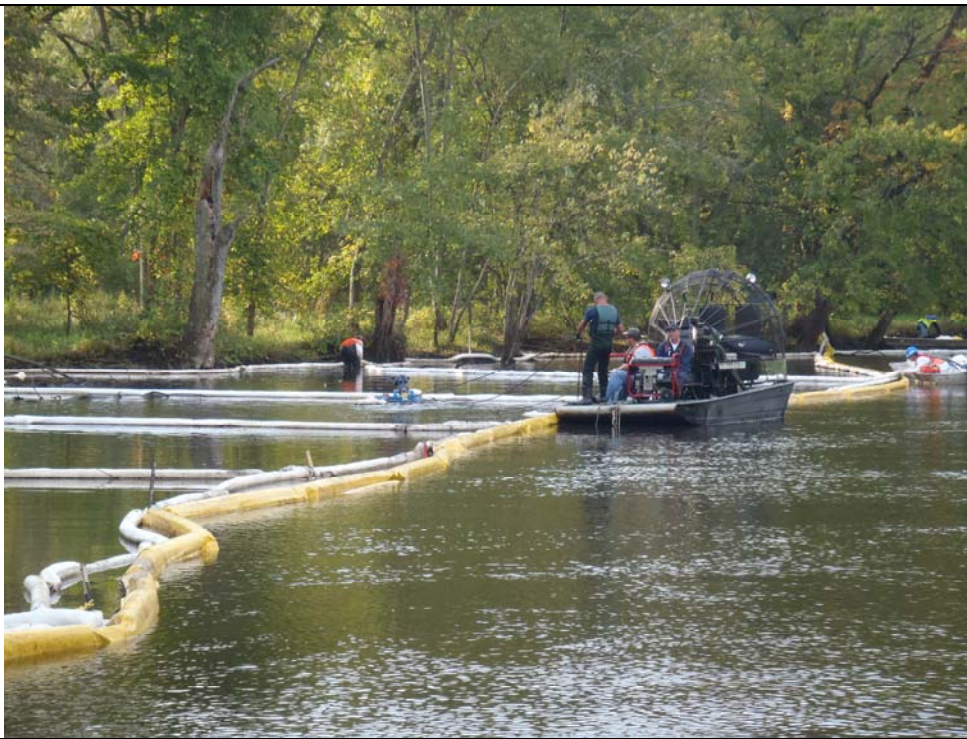
Photograph 2

Description:
Recovery activities in
progress – aeration

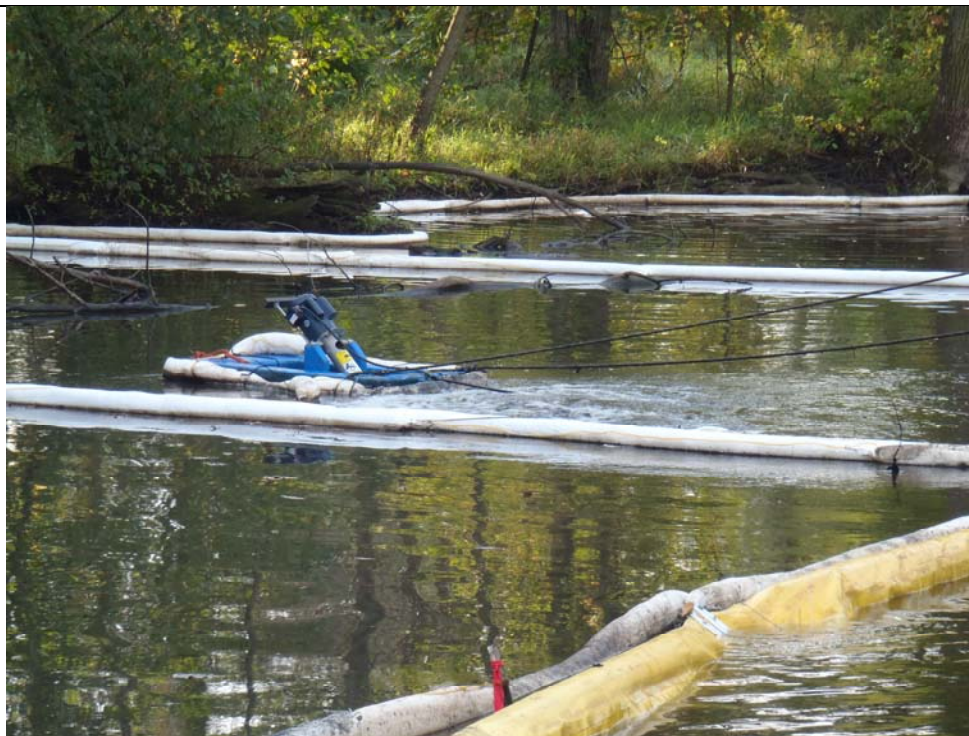
PHOTOGRAPH LOG
Photograph 3

Description:
Recovery activities in
progress – aeration

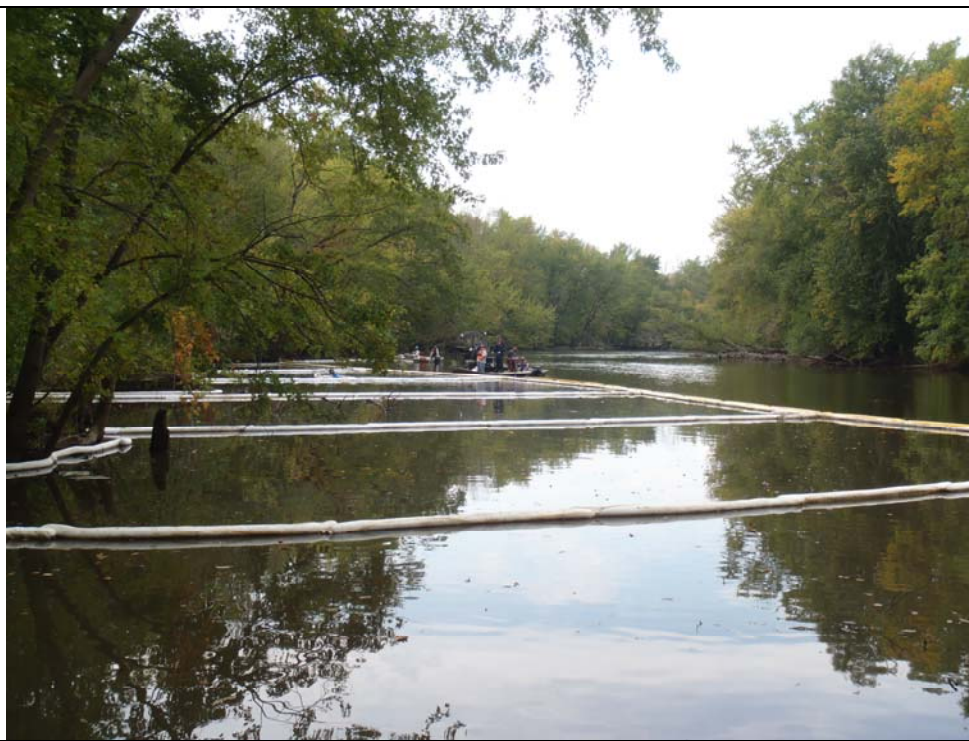
Description:
Recovery activities in
progress – aeration

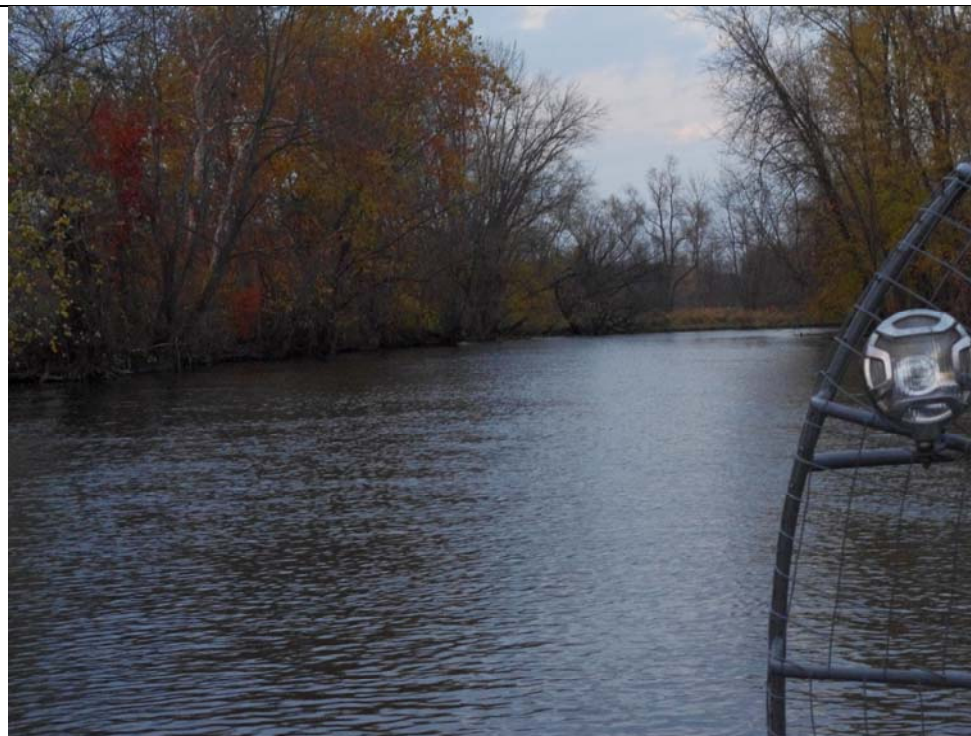
Photograph 5

Description:
Post recovery – recovery
activities complete and
containment removed

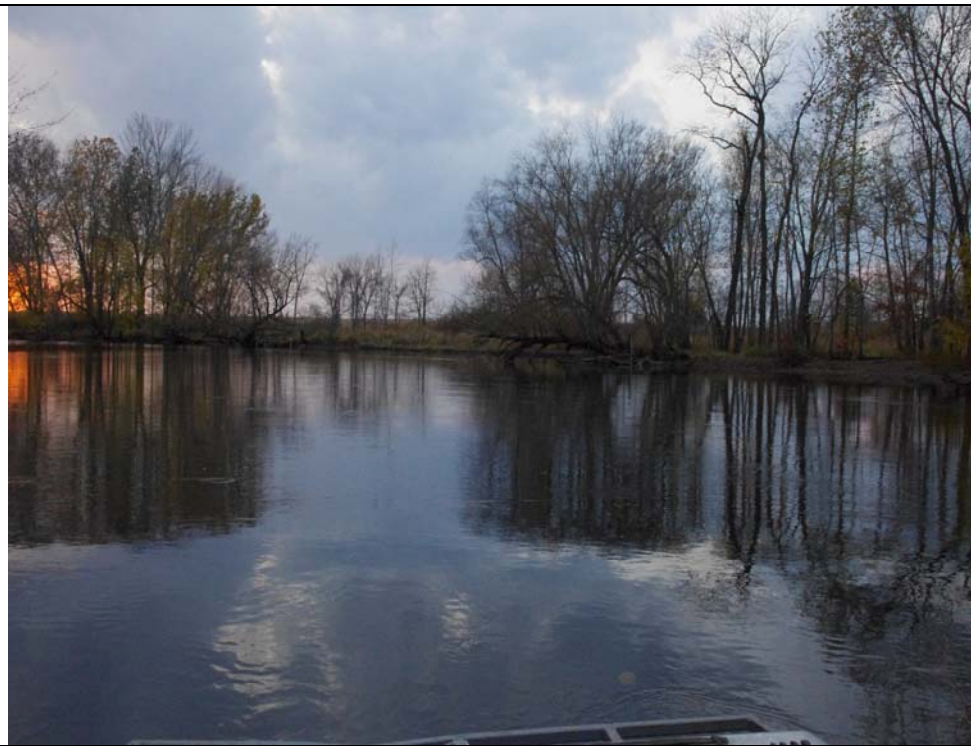
Photograph 6

Description:
Post recovery – recovery
activities complete and
containment removed

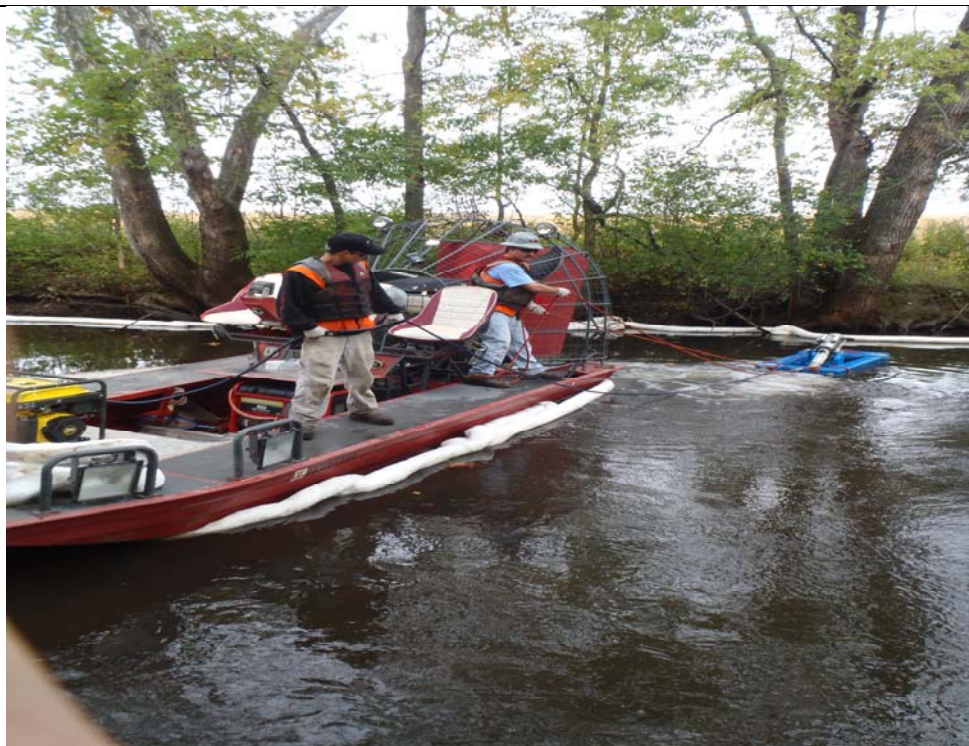
Description:
Recovery activities in
progress - aeration

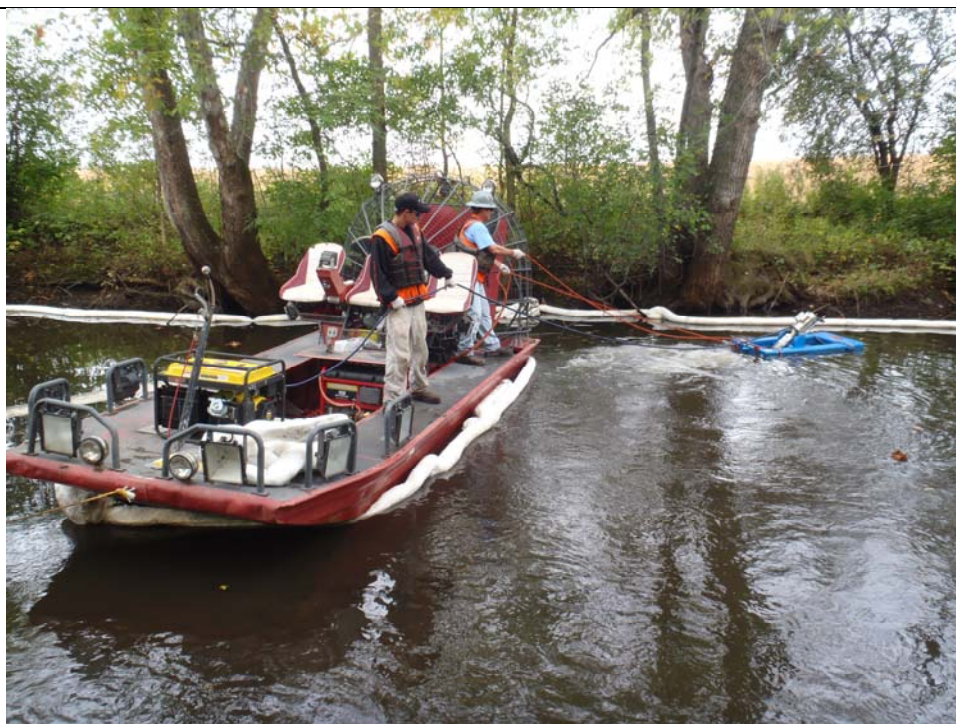
**PHOTOGRAPH LOG**
Photograph 2

Description:
Recovery activities in
progress - aeration

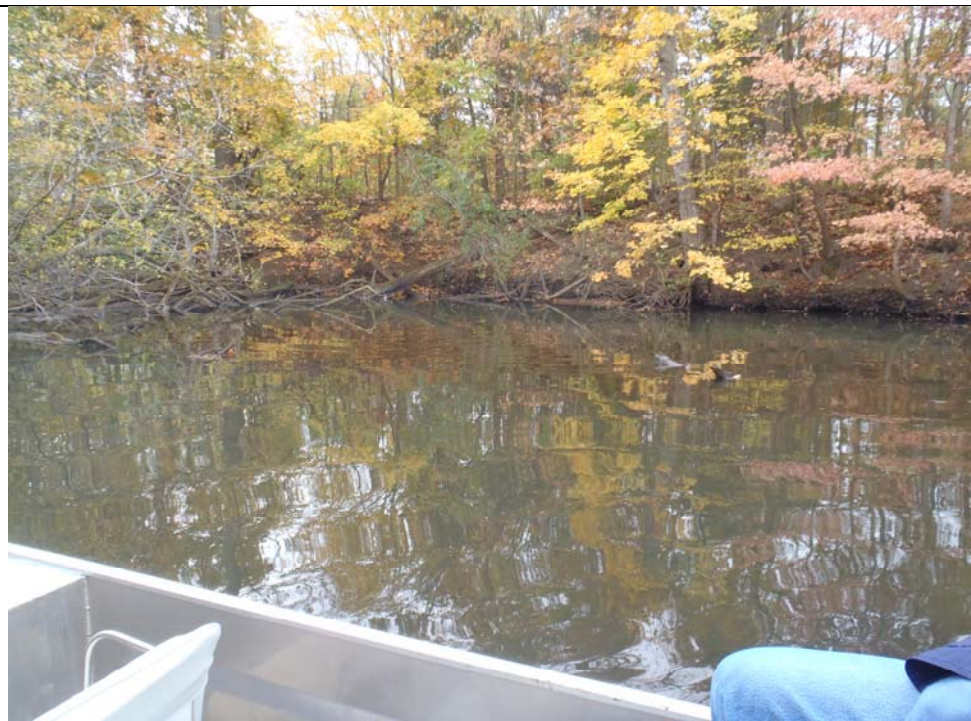
Description:
Site conditions at
determination of no action
needed and sign-off

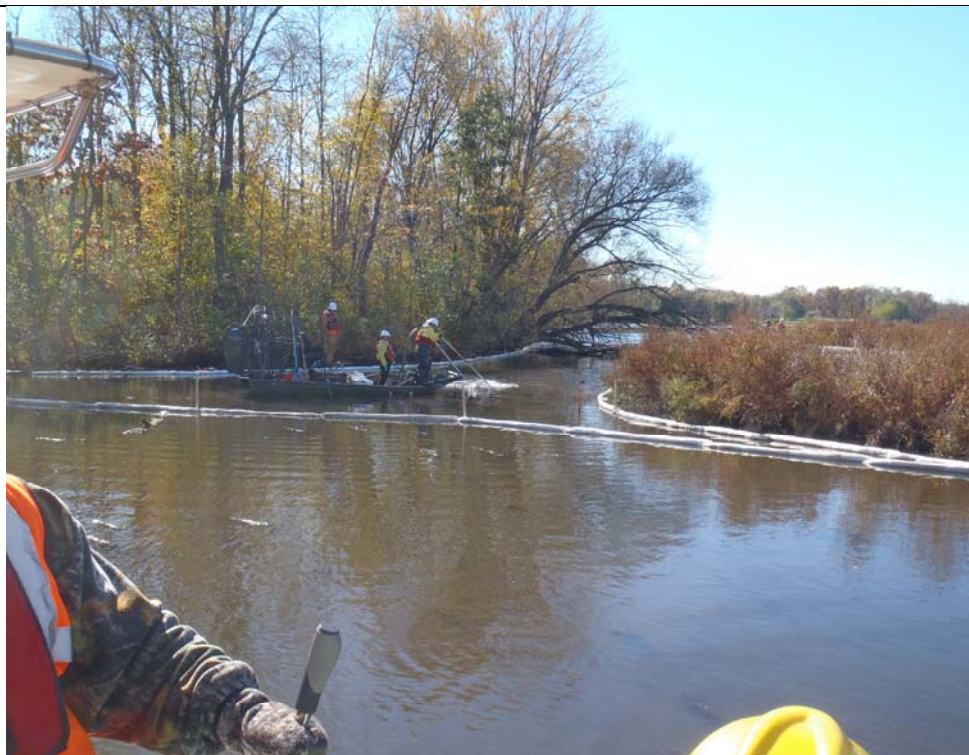
Description:
Recovery activities in
progress – water washing

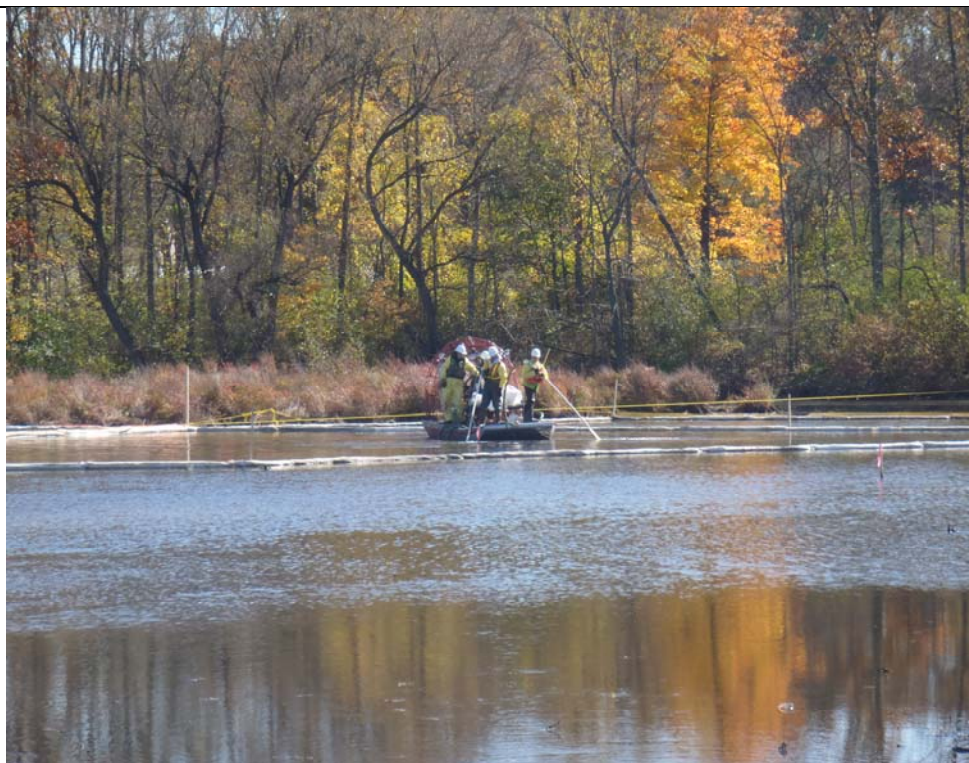
Photograph 2

Description:
Recovery activities in
progress – water washing

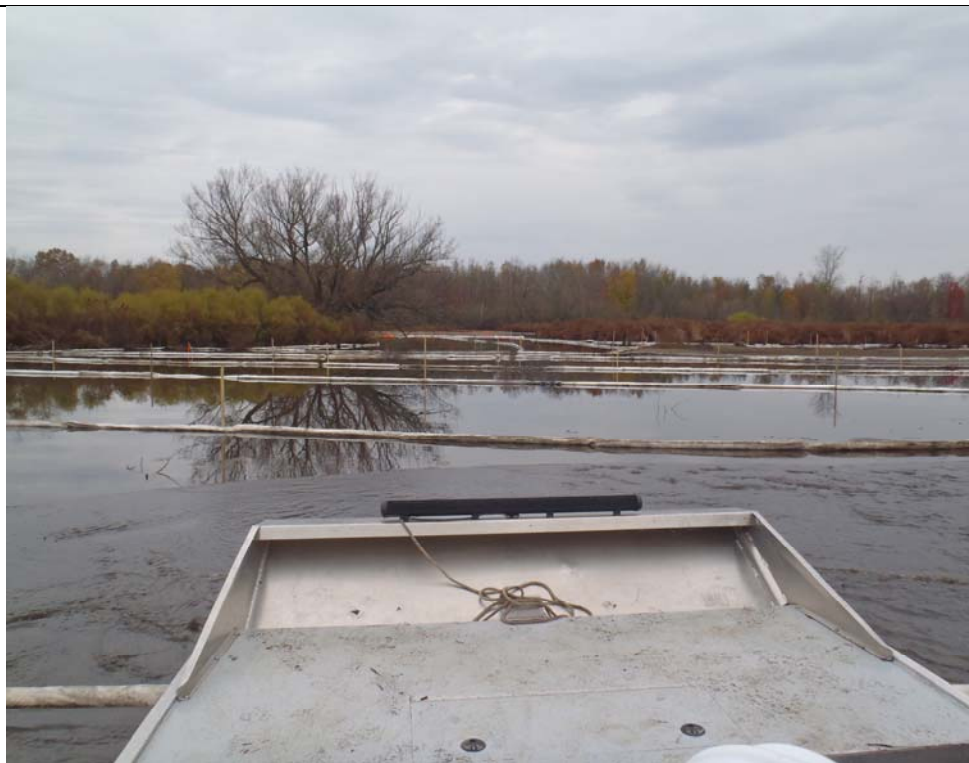
Photograph 3

Description:
Recovery activities in
progress - containment
and cell preparation

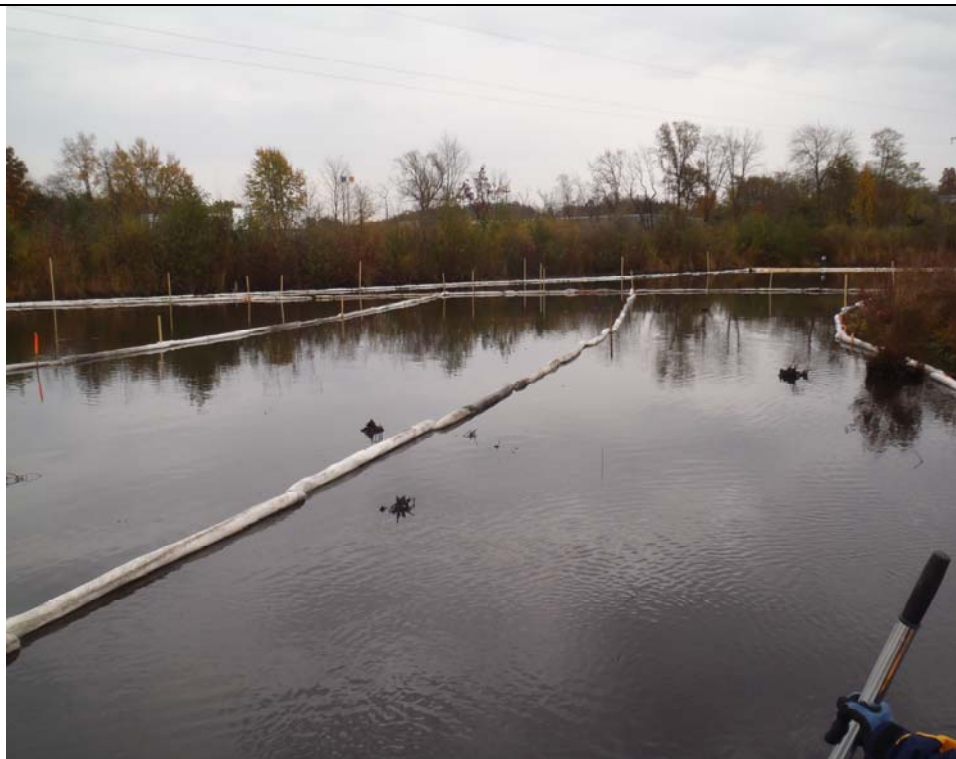
Photograph 4

Description:
Recovery activities in
progress - containment
and cell preparation

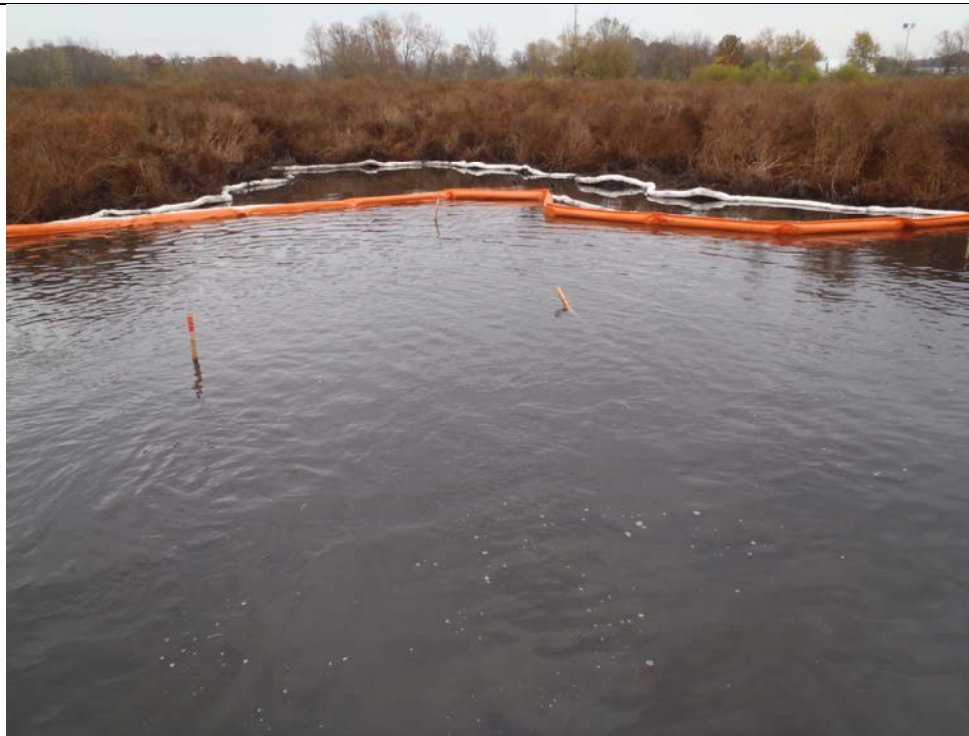
PHOTOGRAPH LOG
Photograph 5

Description:
Recovery activities in
progress - containment
and cell preparation

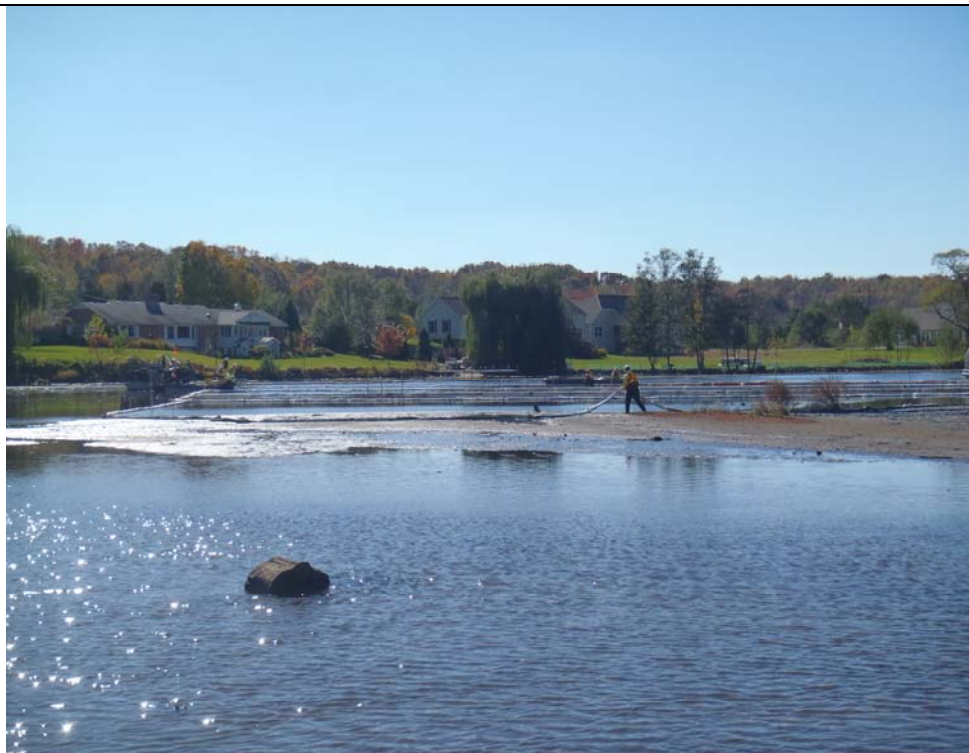
**PHOTOGRAPH LOG**
Photograph 6

Description:
Recovery activities in
progress – water washing

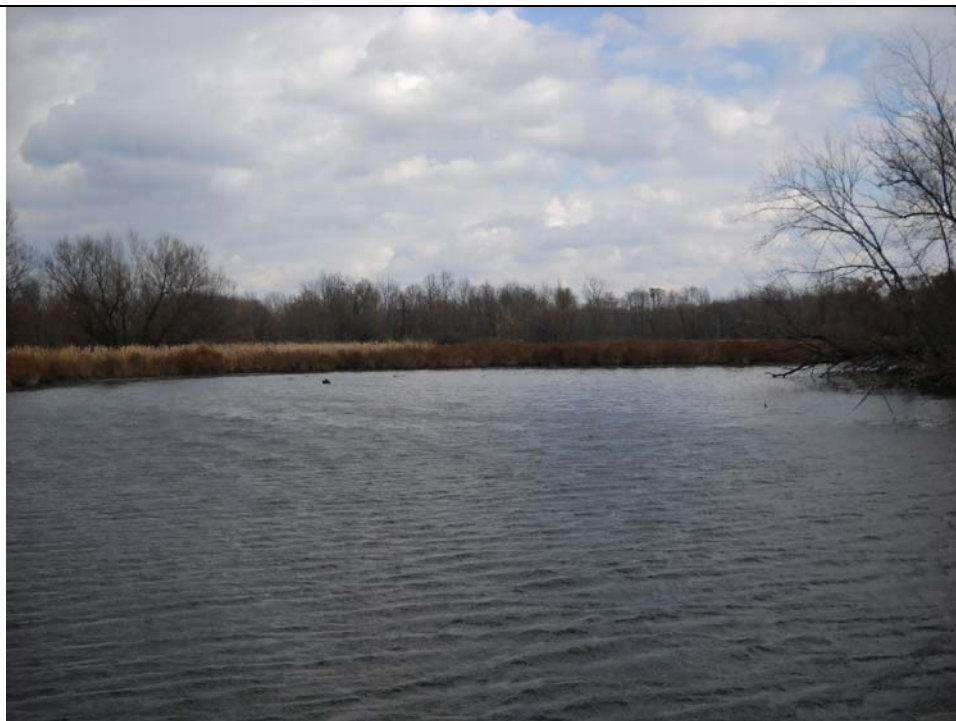
PHOTOGRAPH LOG
Photograph 7

Description:
Recovery activities
complete – containment
ready to be removed

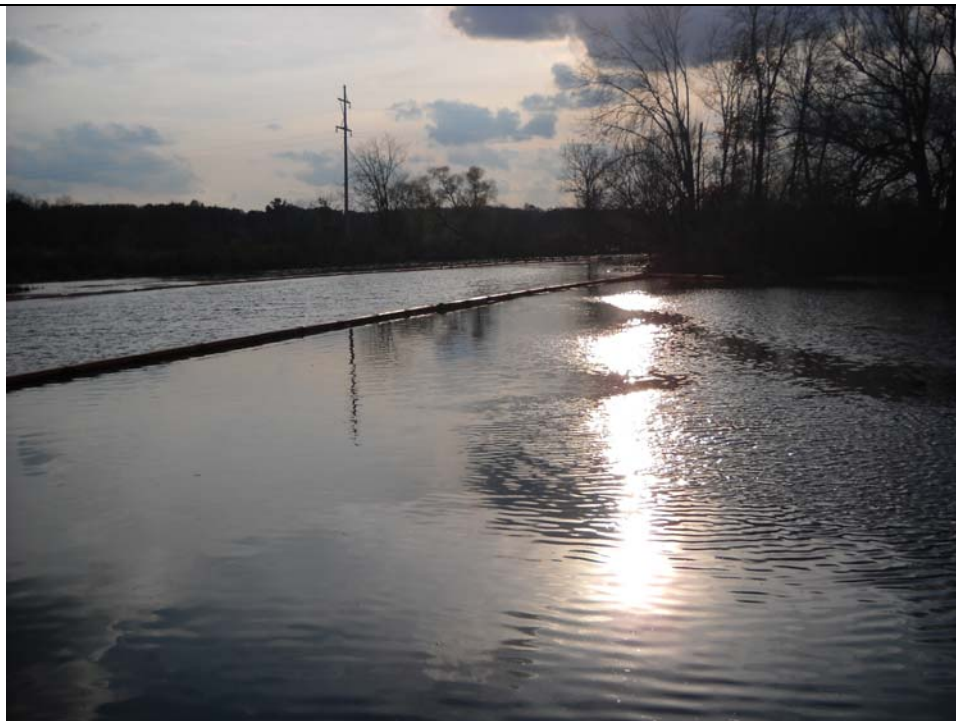
**PHOTOGRAPH LOG**
Photograph 8

Description:
Recovery activities
complete – containment
ready to be removed

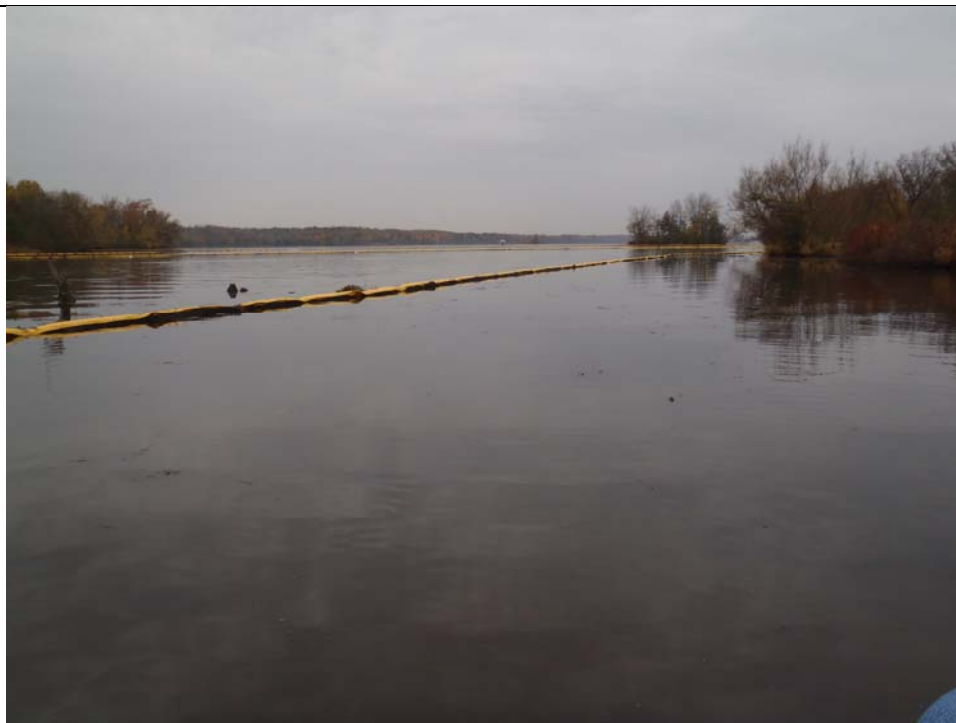
Description:
Site prepared but no
activity determined to be
needed

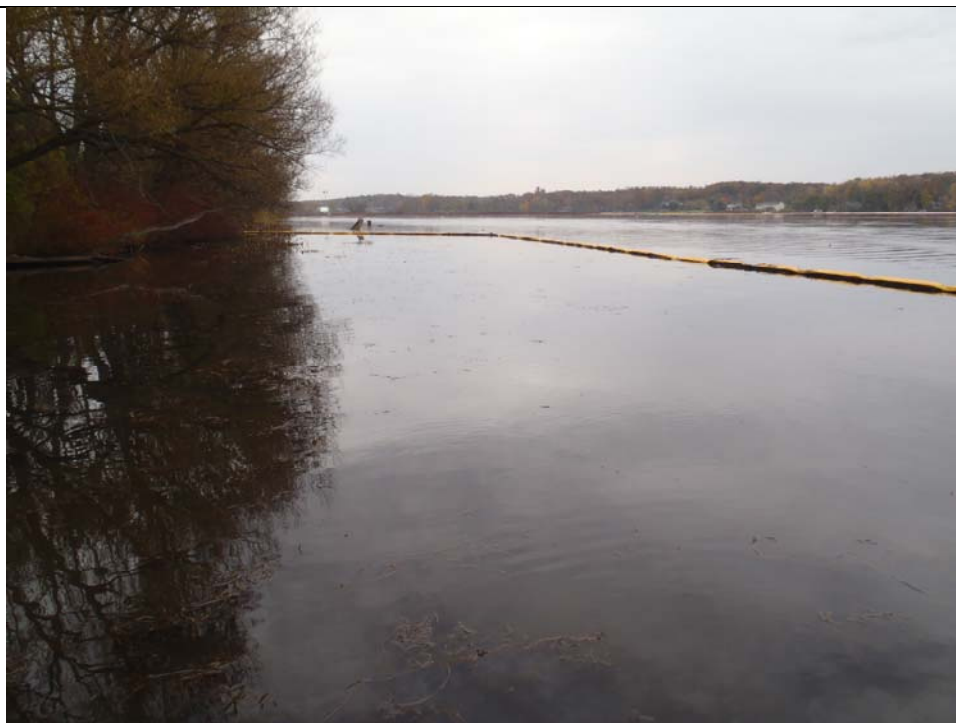
Photograph 2

Description:
Site prepared but no
activity determined to be
needed
